Service Bulletin No. 93-1

Subject: Flap Flutter

Date: June 24, 1993

Models Affected: Sequoia F.8L Falco (all aircraft built from plans and/or kits)

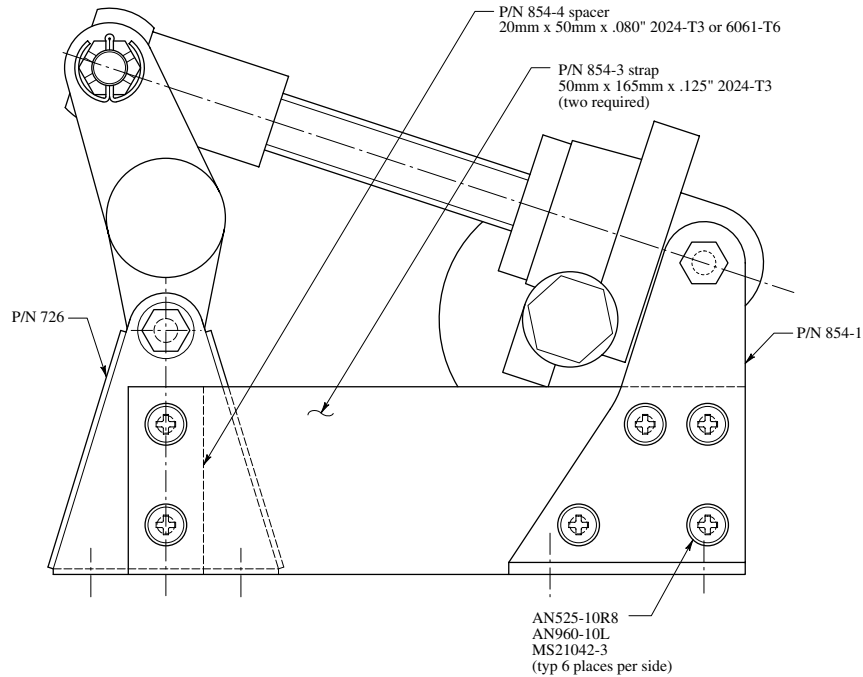
3. Use of countersunk screws. The flap torque tube support (P/N 726) and the flap actuator support brackets (P/N 854-1 & -2) are installed with washer-head screws with the head of the screws on the outside of the plywood skin of the aircraft. On this Falco, the screws were countersunk into the surface with the result that the heads of the screws bear on spruce. This weakens the mounting and adds to the flexing in the flap control system.

3. Install reinforcing straps between P/N 726 torque tube support and P/N 854-1 & -2 flap actuator support mounts as shown below.

To be sure, this installation is a difficult one. In order to accomplish this, you must first remove the actuator and torque tube. The torque tube does not have to be removed from the airplane, only from P/N 726.
